WT-65

This volume is the report of a test program to measure under carefully controlled conditions on the ground the effects of an atomic bomb on aircraft and missile structures. Some measurements of the blast and thermal phenomena peculiar to the USAF problem are included.

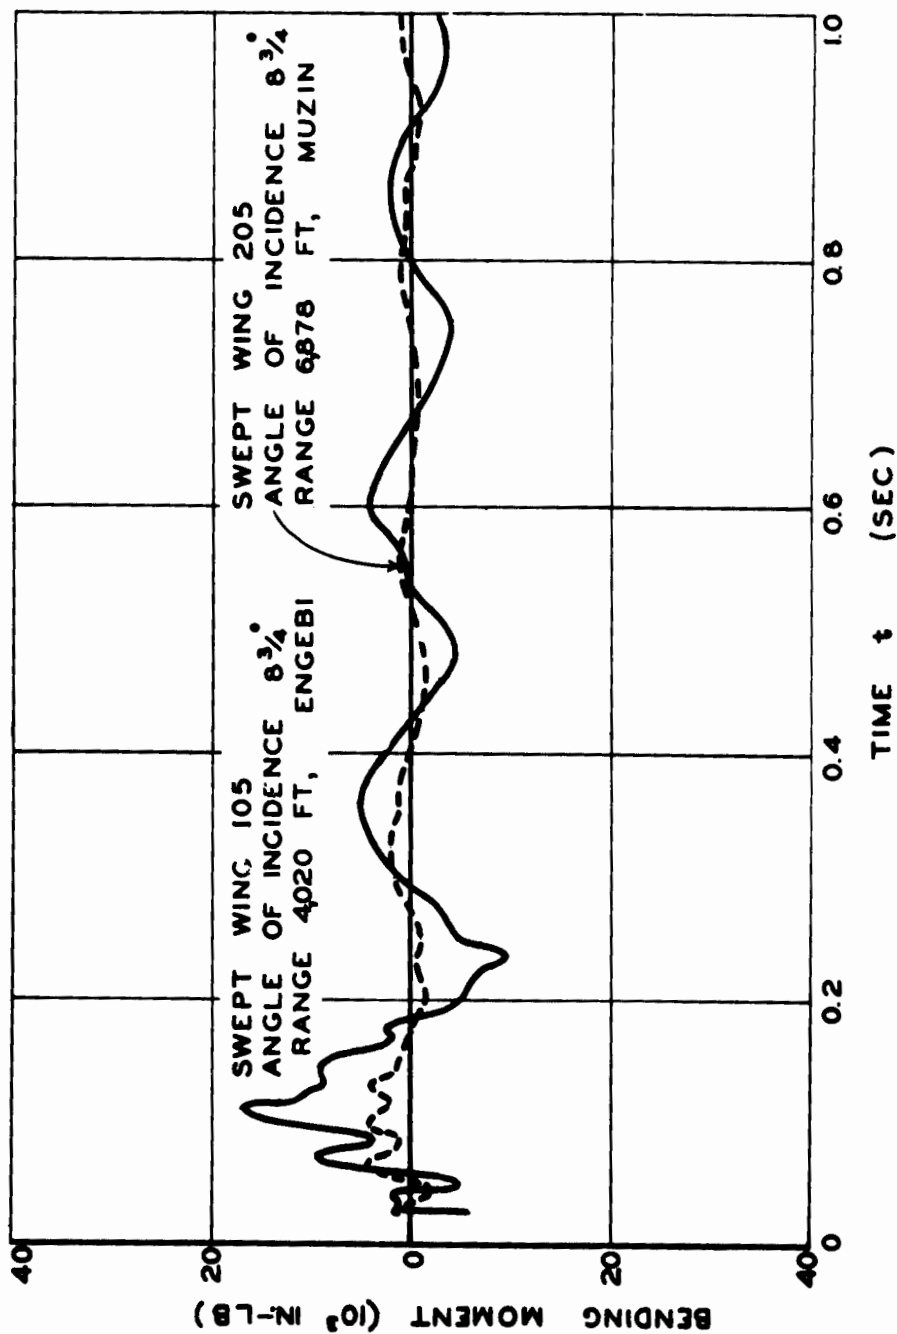
Fig. 8.50 Comparison of the Variation of Bending Moment with Time at Station 9, Outboard, for Two Swept Wings at Different Ranges

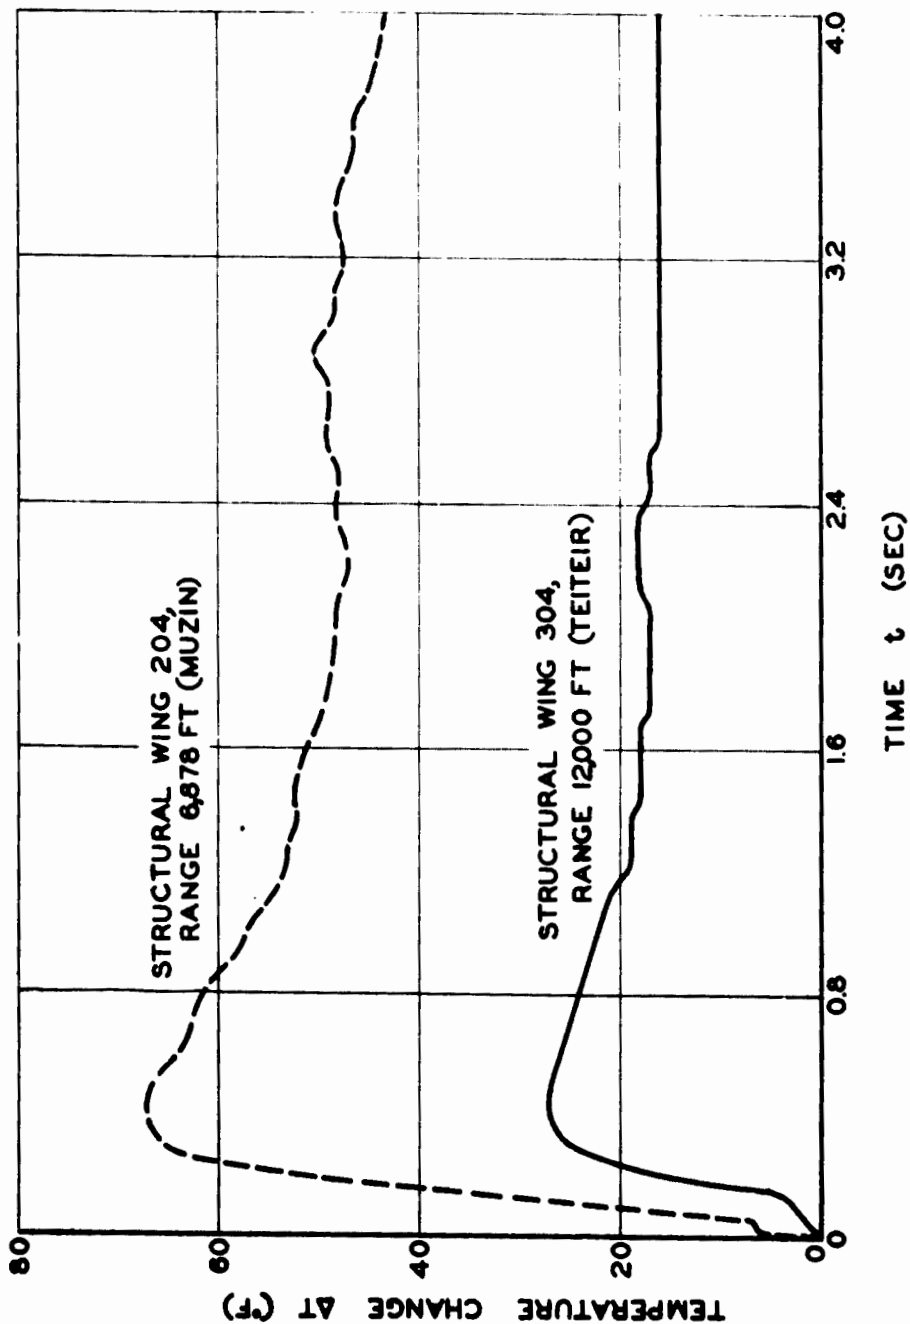
Fig. 5.53 Variation of Temperature Change with Time at a 25° Incidence Point on the Outside Skin Surface of Two Wings at Different Ranges

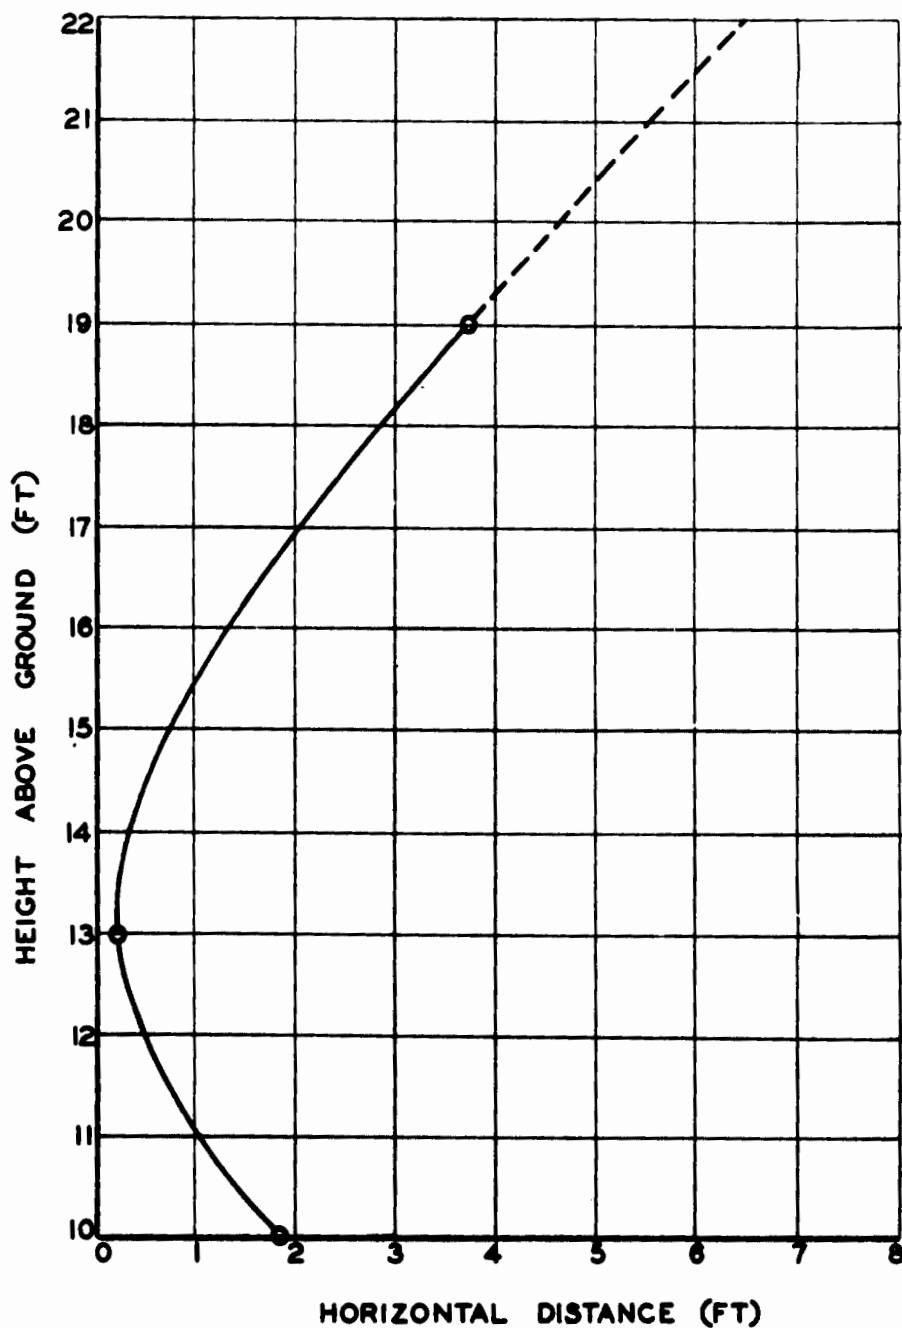
Fig. 5.61 Vertical Profile of Blast Front As Determined by Electronic Chronographs and Blast Switches

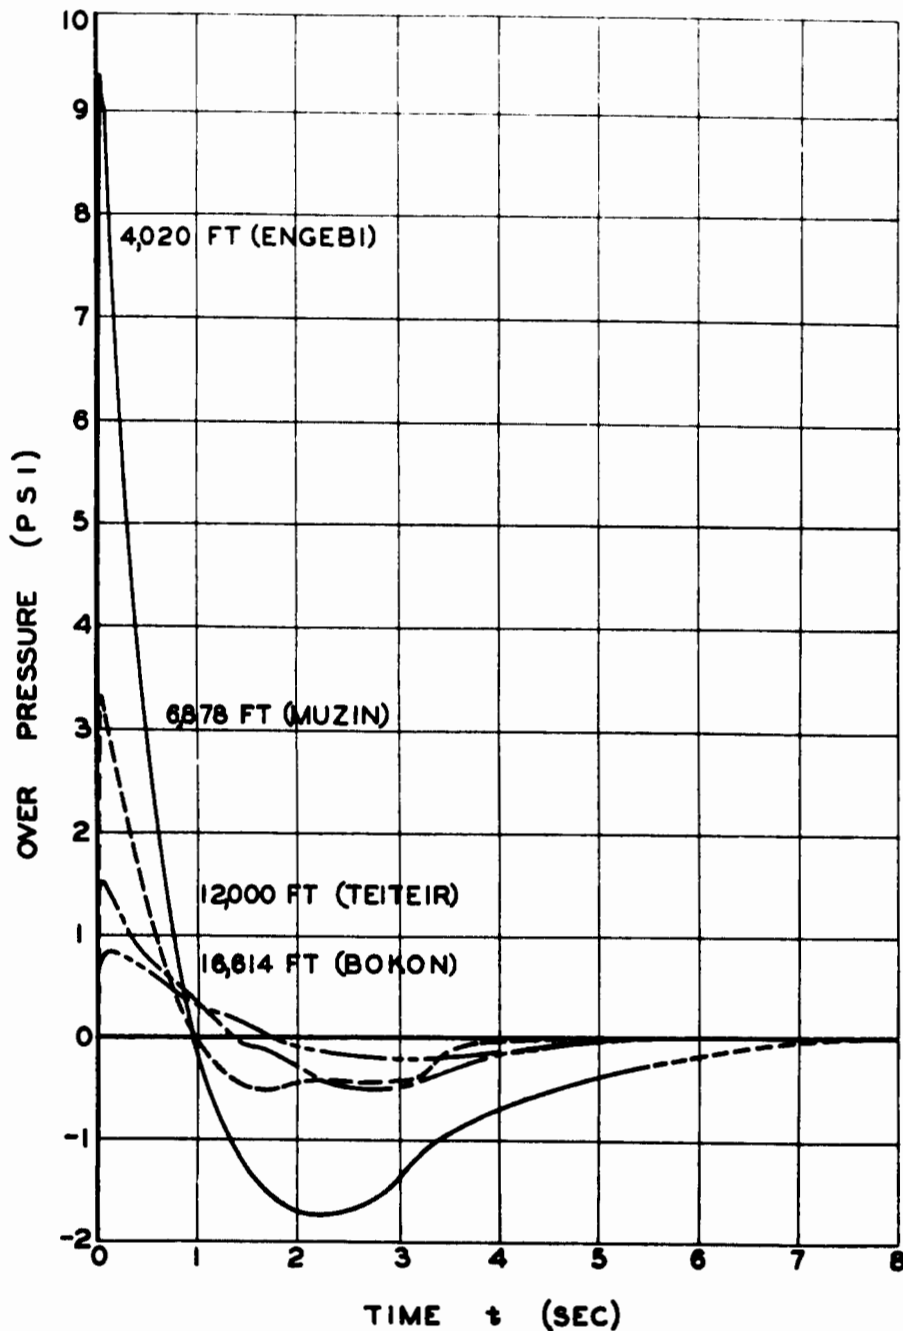
Fig. 5.62 Variation of Blast Pressure with Time at Each of the Four Test Sites As Determined from Interferometer Gauges

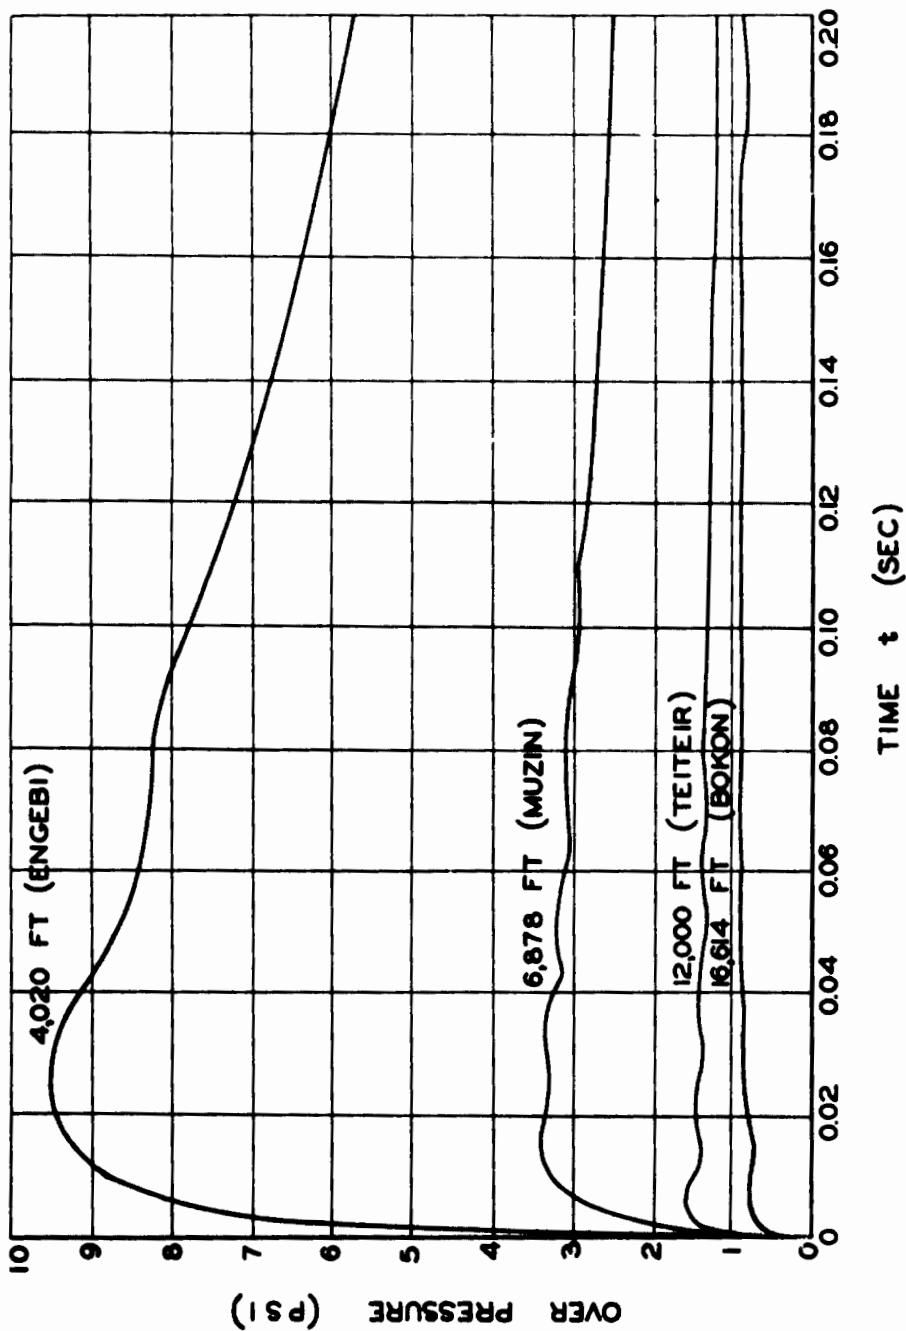
Fig. 5.63 Variation of Blast Pressure with Time for the First 200 Msec at Each of the Four Test Sites As Determined from Interferometer Gauges

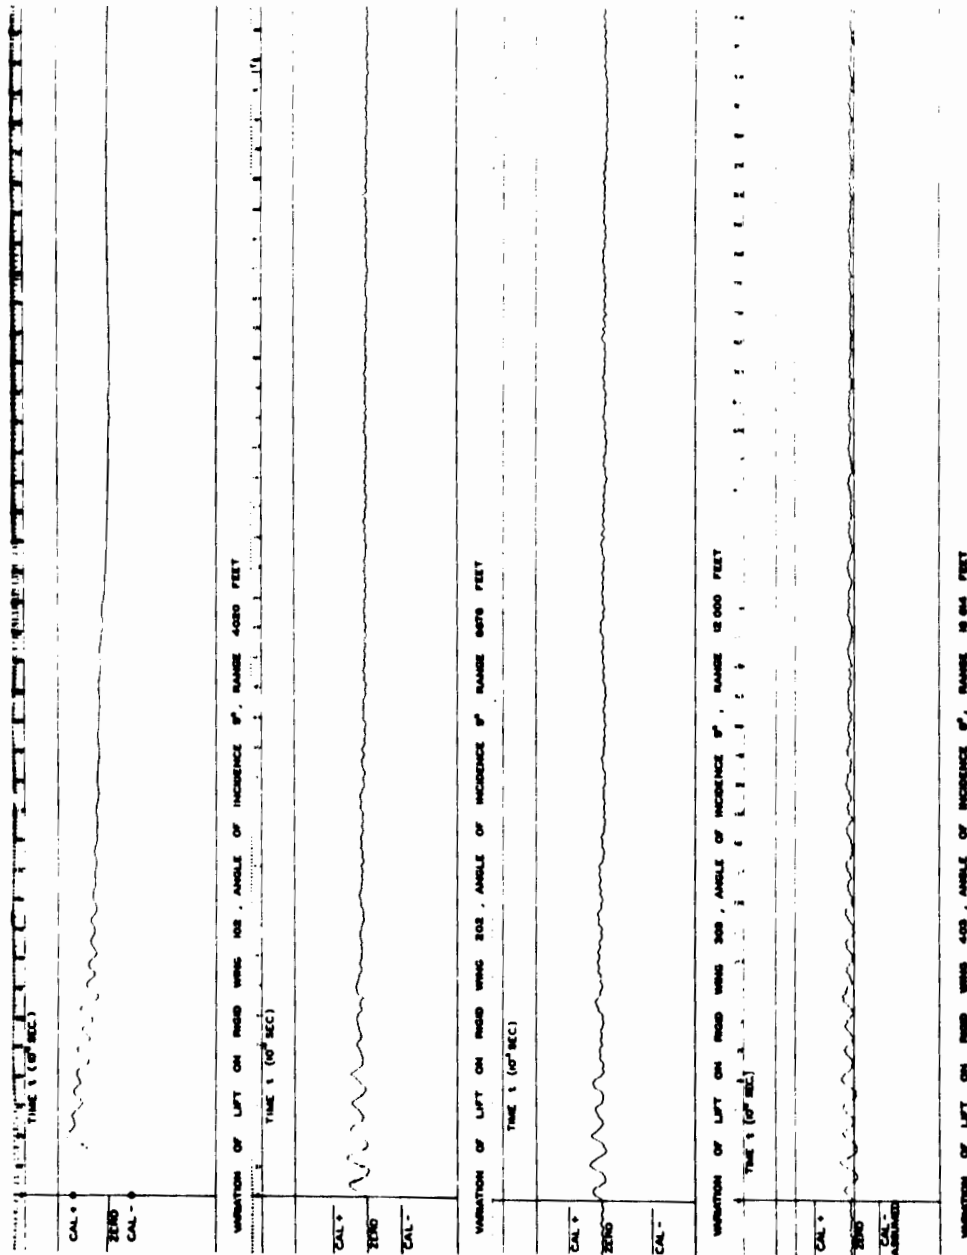
Fig. 6.1 Oscillograph Reproduction of the Magnetic-tape Record of the Lift for Four Wings

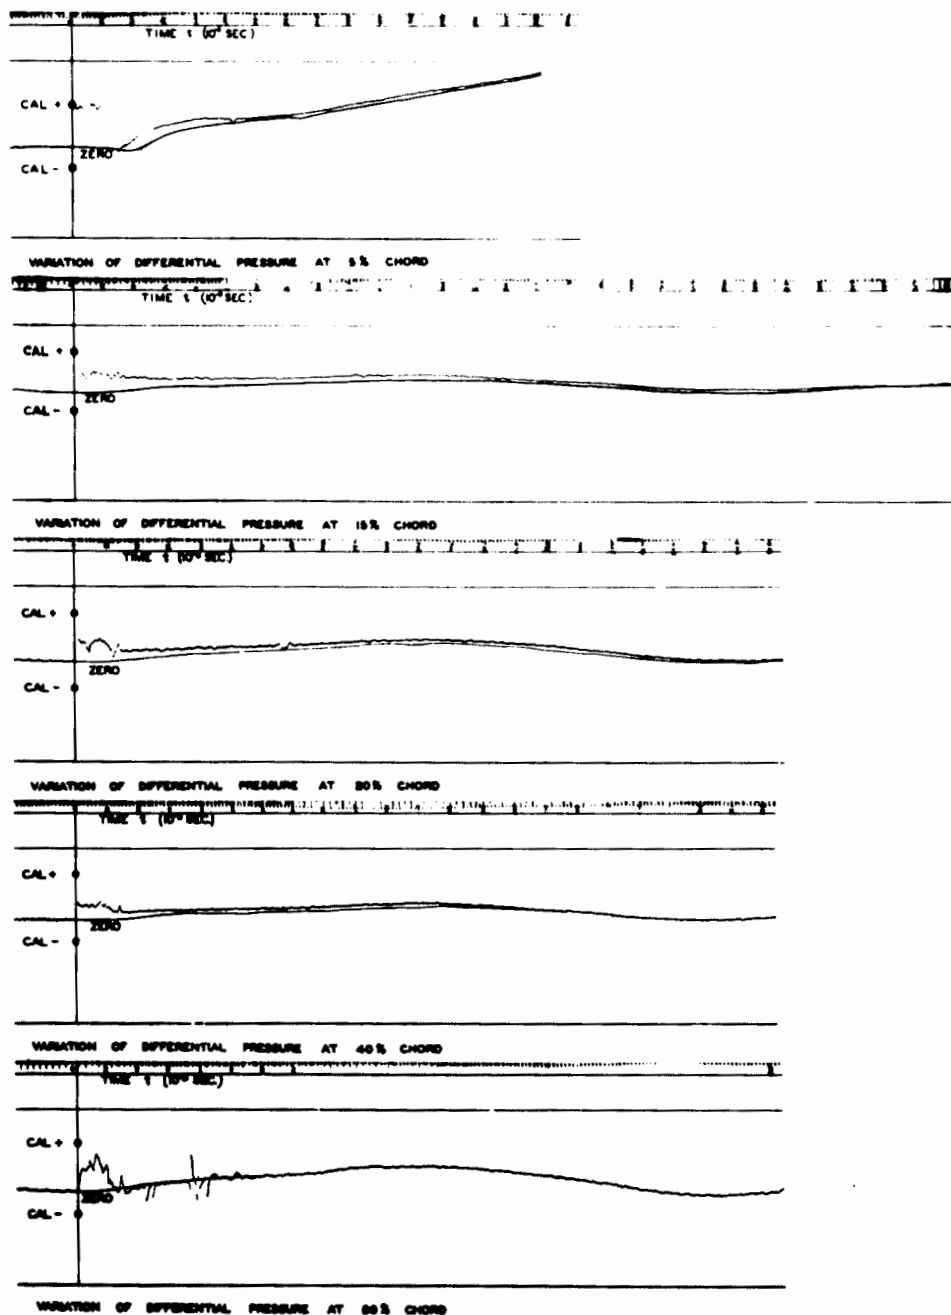
Fig. 6.2 Oscillograph Reproductions of the Magnetic-tape Record of the Variation of Differential Pressure with Time at Several Chordwise Stations of Rigid Wing 102, Angle of Incidence  $9^\circ$ , Range 4,020 Ft

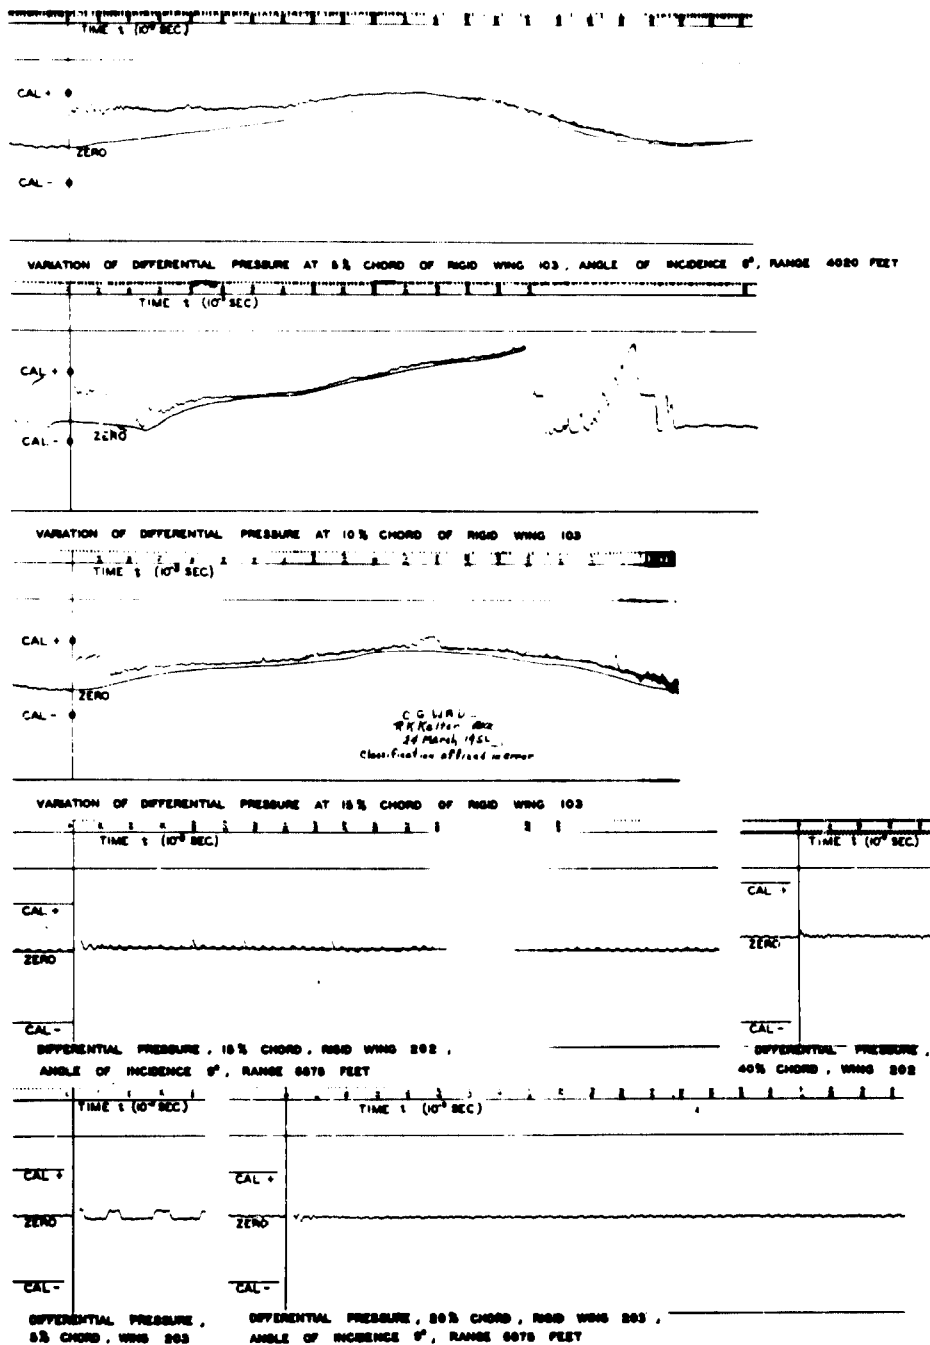
Fig. 6.3 Oscillograph Reproductions of the Magnetic-tape Record of the Variation of Differential Pressure with Time at Several Chordwise Stations of Rigid Wings 103, 202, and 203

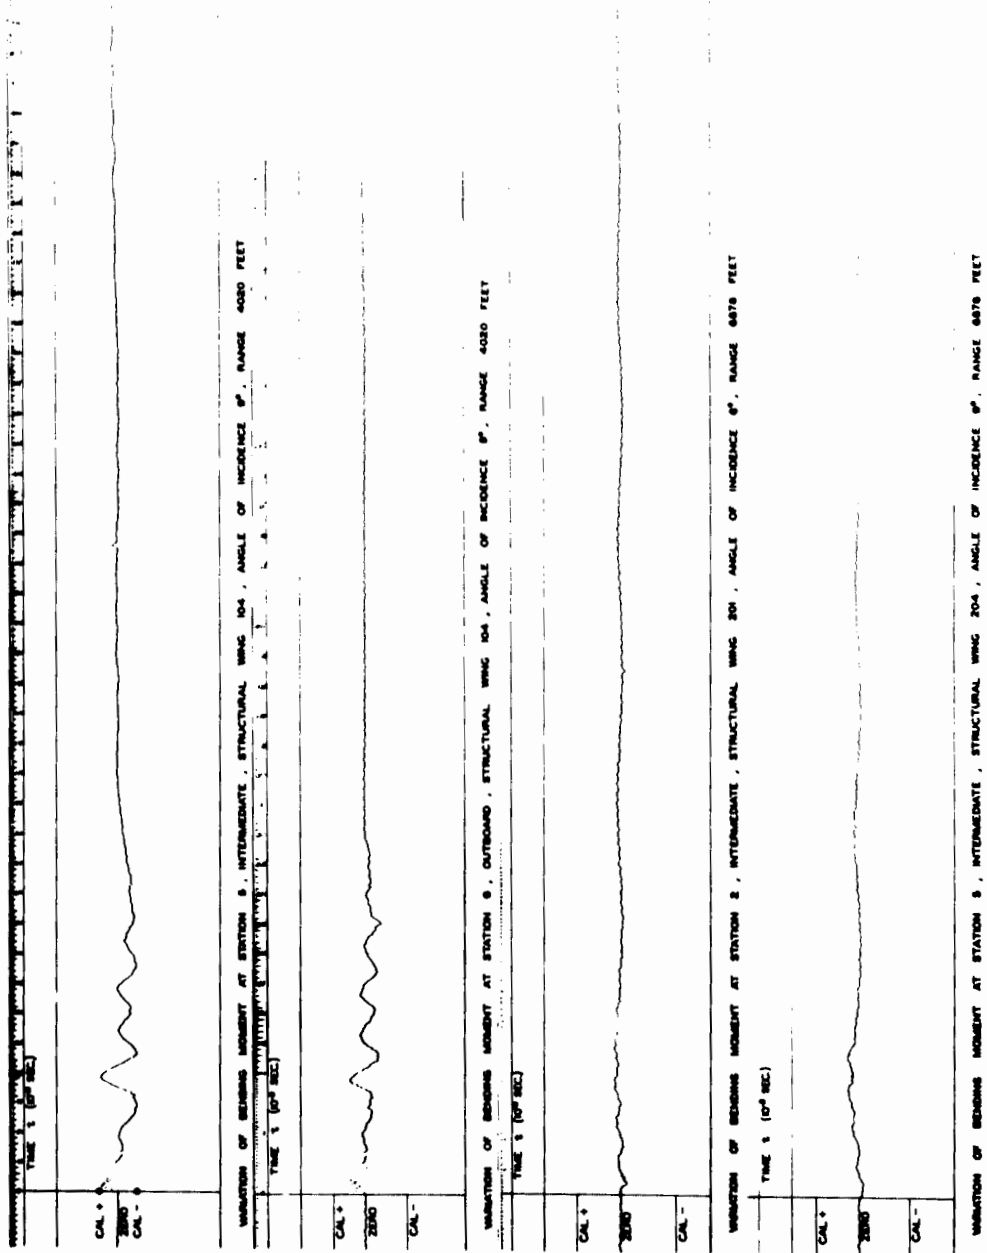
Fig. 6.7 Oscillograph Reproductions of the Magnetic-tape Record of the Variation of Bending Moment with Time at Spanwise Stations of Structural Wings 104, 201, and 204

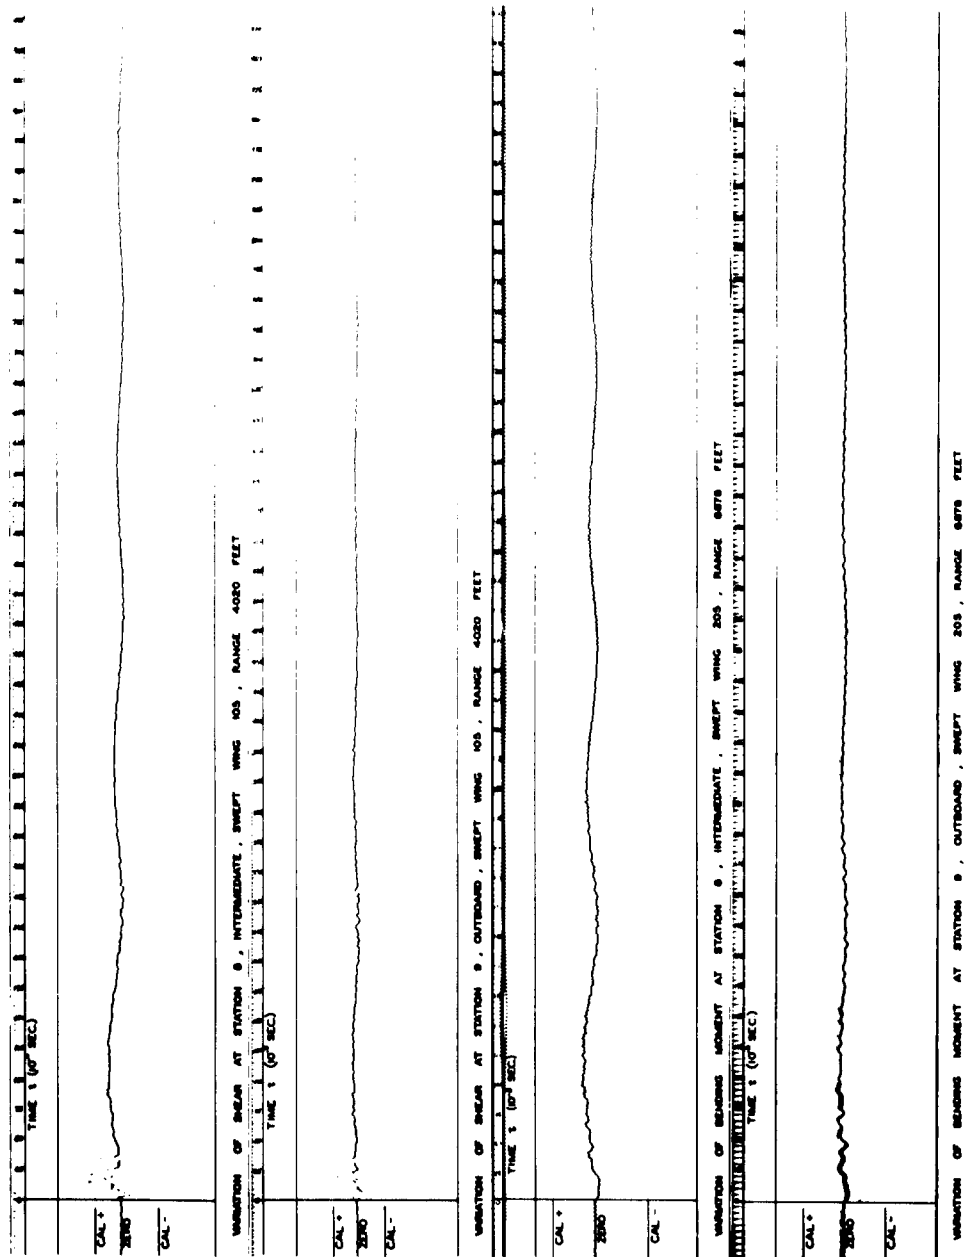
Fig. 6.9 Oscillograph Reproductions of the Magnetic-tape Record of the Variation of Shear with Time at Two Stations of Swept Wing 105; and of Bending Moment with Time at Two Stations of Swept Wing 205

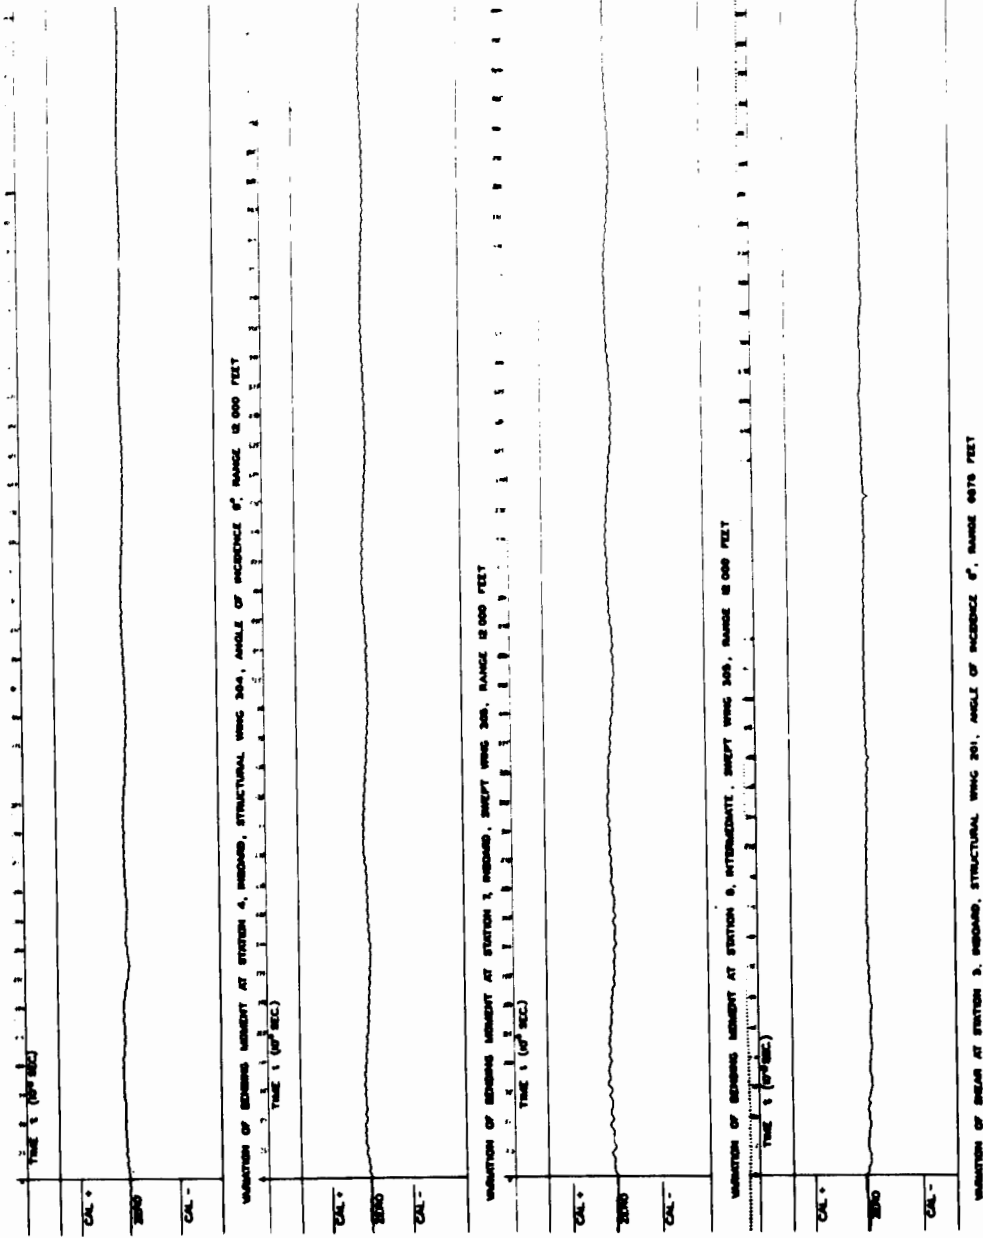
Fig. 6.10 Oscillograph Reproductions of the Magnetic-tape Record of the Variation of Bending Moment with Time at Station 4, Inboard, of Structural Wing 304; at Two Stations of Swept Wing 305; and of Shear with Time at Station 3, Inboard, of Structural Wing 201
